## Nafziger Road Bridge Load Testing

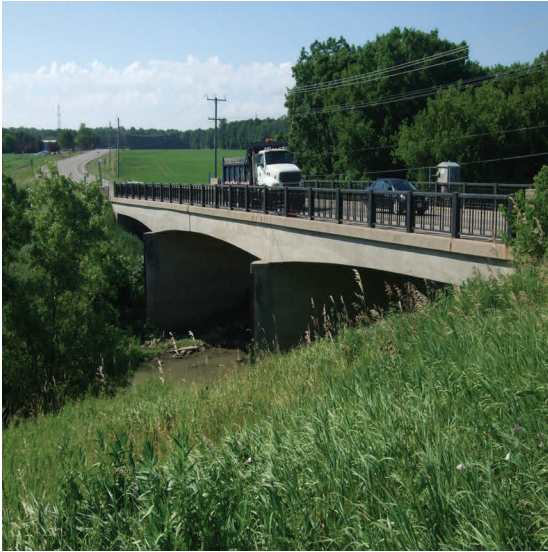
Nafziger Road Bridge is a 3 span reinforced concrete bridge. There is no load limit posting on the bridge but two previous structural evaluations for the bridge indicated that the center span was deficient with respect to the Highway Bridge Code. There are no drawings for the bridge and therefore the reinforcing details are unknown and the Engineer is forced to make assumptions on the bridge construction when structural evaluations are made.

Fiber Optic strands were installed on the T beams of the center span and the bridge was load tested.

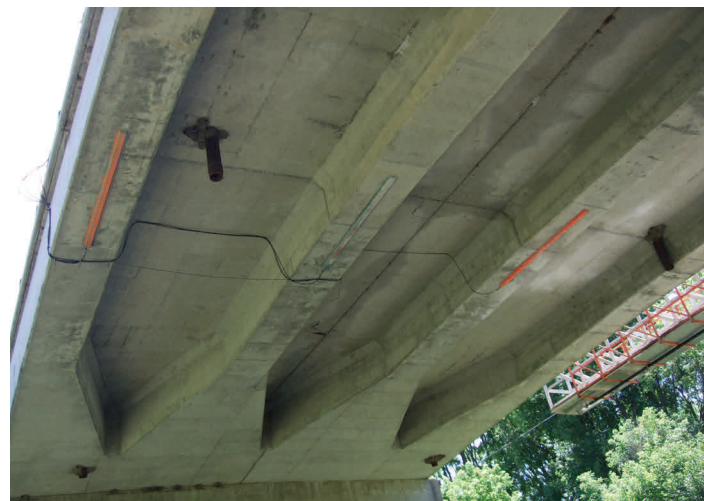
The load testing showed that the center span of the bridge performed significantly better than theoretical calculations would suggest for the bridge. The load test also showed that the load distribution to the beams was different than what the Bridge Code specifies for the designer to use.

The OSMOS technology showed the center span of the bridge complies with the requirements of the Highway Bridge Code and does not need strengthening. This has resulted in a significant saving of money to the owner of this bridge and the Owner can invest money on repairs and that he knows are a wise investment. This bridge was subsequently enhanced with new guide rails and repair to concrete spalling areas with full confidence that the bridge is structural sound and the money invested in the bridge was wisely spent.
